## LAND CORNER RECORD

| Index: G-15 | Corner: C1/4 | State of Indiana - Hoosier National Forest | | |
| Section: 10 | Township: 7N | Range: 1E | P.M.: 2nd | County: Monroe |

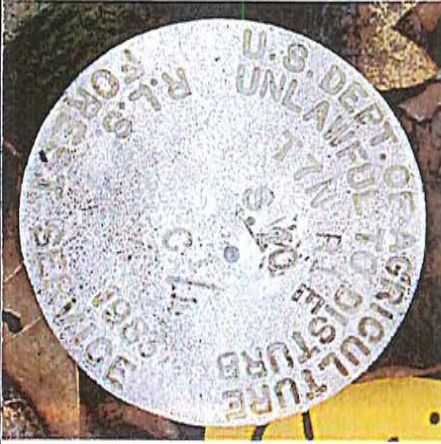
| Reference Objects: | Object or Tree Species: | Diameter: | Bearing: | Distance: |
|---|---|---|---|---|
| Monument Found or Set: | A 3" aluminum monument stamped "T7N R1E S.10 C1/4 1983" found 0.2' above grade. | | | |

Monument is a 3" aluminum monument stamped "T7N R1E S.10 C1/4 1983" found 0.2' above grade, a carsonite post is located 2.0' north of the monument, +/- 40' and 100' south of two old road beds running east-west with a ridge, on a steep slope, +/- 150' north of a small creek that is emptying into Lake Monroe, surrounded by mature forest, 25' south of a road bank, a rock cairn at the base of the monument.

The record monument was found undisturbed and maintained by establishing two new bearing trees and one new reference object.

Two new bearing trees were marked with a bearing tree sign, paint, and mag nail.
